Case Report

Cardiac Perforation by Permanent Pacemaker Lead, One Year after Implantation — An Unusual Occurrence and Its Management

[J Indian Med Assoc 2022; 120(3): 66-7]

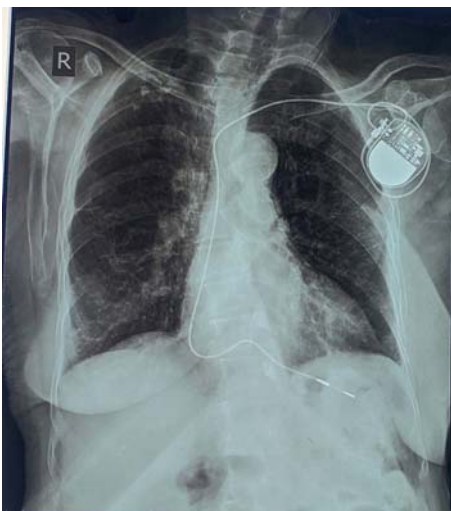
Fig 1 — Initial Postoperative Chest X-Ray done after implantation of Permanent Pacemaker done 1 year ago.

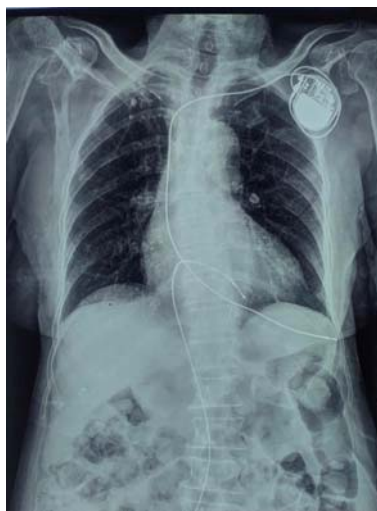
After 14 months of implantation, the patient returned to the Emergency with Recurrent Syncopal Attacks. Electrocardiogram at Emergency Room showed Heart rate of 40 beats per minute with Pacemaker capture failure. She was immediately put on Temporary Pacemaker. Chest X-ray and subsequently Computed Tomography (CT) scan of Thorax had been done and Permanent pacemaker lead tip was found in Left Pleural Space touching the base of Left Lung, perforating through the RV Apex, Pericardium and Left Pleura.

Fig 2 — Chest X-Ray done 1 year later shows cardiac perforation by the permanent pacemaker lead (White arrow). The temporary pacemaker lead is also seen (Red arrow).

Anticipating life threatening complications with transvenous lead removal, open surgical removal of the Pacemaker lead, was planned. After a Manubrium-sparing Lower Median Sternotomy, perforation site was identified and a pledgeted 4-0 Polypropylene Purse-string Sutures was taken around it. There were no collections in

Pericardial and Pleural Sacs. The lead tip was carefully withdrawn from the Left Pleural Cavity, cut and removed. At the same time, the Permanent Pacemaker pocket was explored in the Left Subclavicular Region. Pulse generator along with the remaining lead had been pulled out and removed gently. RV Apical perforation site was closed by the previously taken purse-string suture. Subsequently another Epicardial permanent Pacemaker lead was implanted over the Right Ventricular Apex and its pulse generator was placed in a subcutaneous pocket created in the Epigastrium, approached through the same incision. After checking Haemostasis, an Intercostal Chest Drain was placed in the Left Pleural Cavity. The pericardium was closed using interrupted polyglactin sutures leaving multiple small pericardial windows. The Chest incision was closed in layers. Patient was extubated within a couple of hours after shifting to the Cardiac Surgery Postoperative Intensive Care Unit (ICU). The peri-operative period and follow up at 1 week, 15 day and 1 month were uneventful.

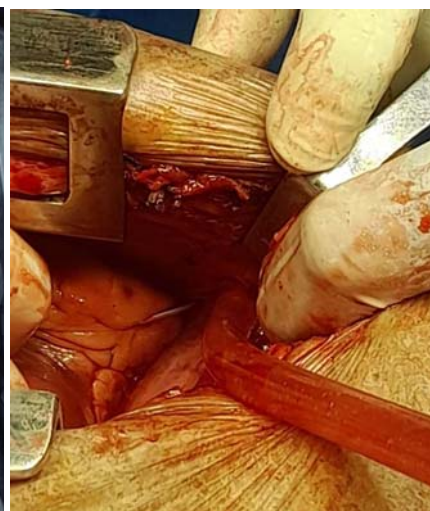
Fig 3 — Perforation of the cardiac apex caused by the permanent pacemaker lead (Yellow arrow) can be seen. The culprit lead then proceeds to perforate the pericardium and penetrate the left pleural space.
